**DEPARTMENT OF TRANSPORTATION**

Contract #: 04-0120F4Cty: SF/ALA Rte: 80 PM: 13.2/13.9File #: 1.28**WELDING INSPECTION REPORT****Resident Engineer:** Casey, William**Address:** 333 Burma Road**City:** Oakland, CA 94607**Report No:** WIR-026965**Date Inspected:** 29-Dec-2011**Project Name:** SAS Superstructure**OSM Arrival Time:** 700**Prime Contractor:** American Bridge/Fluor Enterprises, a JV**OSM Departure Time:** 1730**Contractor:** American Bridge/Fluor Enterprises, a JV**Location:** Jobsite**CWI Name:** As noted below**CWI Present:** Yes No**Inspected CWI report:** Yes No N/A**Rod Oven in Use:** Yes No N/A**Electrode to specification:** Yes No N/A**Weld Procedures Followed:** Yes No N/A**Qualified Welders:** Yes No N/A**Verified Joint Fit-up:** Yes No N/A**Approved Drawings:** Yes No N/A**Approved WPS:** Yes No N/A**Delayed / Cancelled:** Yes No N/A**Bridge No:** 34-0006**Component:** SAS OBG**Summary of Items Observed:**

## WELDING INSPECTION REPORT

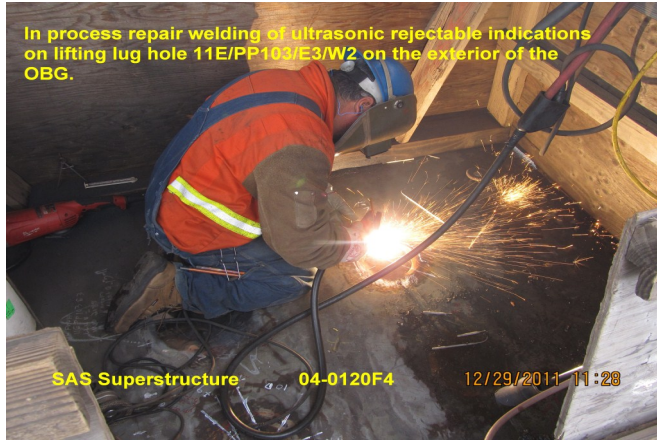
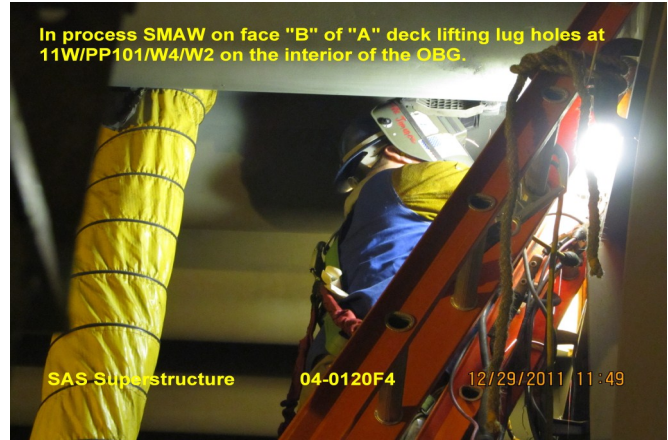
This QA Inspector randomly observed QC Inspector Sal Merino perform a Magnetic Particle (MT) inspection of the back gouged weld area on face "B" of "A" deck lifting lug holes W2 and W4 located at 11W/PP101/W4. This QA Inspector observed that Mr. Merino found no rejectable indications and the work appeared to be in general conformance with the contract specifications.

This QA Inspector randomly observed ABF welder Mike Jimenez (Welder ID 4671) performing welding operations as per the Shielded Metal Arc Welding (SMAW) process in the (4G) overhead position on "A" deck Lifting Lug Hole W2 at 11W/PP101/W4. This QA Inspector observed the use of E7018-H4R electrodes and QC Inspector Sal Merino verify that the preheat temperature and that the welding parameters (Amps=135) were in accordance with ABF-WPS-D15-1110A-Revision 1. The welding parameters observed at this location appeared to be in general compliance with approved WPS and the contract specifications.

This QA Inspector observed QC Inspector Sal Merino utilize a Bridge Cam Gage to measure the fit-up of the 20 mm plate in the BU-4a joint on lifting lug hole W4 at 12W/PP111/W3. This QA Inspector verified the fit-up as acceptable and employed a 65°C Tempilstik to ensure the minimum pre-heat temperature had been achieved. This QA Inspector randomly observed ABF welder Todd Jackson (welder ID 4639) performing the Shielded Metal Arc Welding (SMAW) process in the (1G) flat position and observed the QC Inspector verify the welding parameters were in accordance with ABF-WPS-D15-1050A-CU. This QA Inspector made subsequent observations throughout the shift to monitor quality and noted that the work was in progress and appeared to be in general compliance with the approved WPS and the contract specifications.

This QA Inspector randomly observed ABF welder Salvador Sandoval performing the back-gouge operation of ultrasonic rejectable indications on “A” deck Lifting Lug Holes W2 and W4 at 11E/PP103/E3 located at “Y” 78 mm: (20 mm wide; 540 mm length; and 10 mm in depth) on W4 at “Y” 110 mm: (20 mm wide; 330 mm length; and 10 mm in depth). This QA Inspector observed QC Inspector Sal Merino perform a Magnetic Particle Inspection (MT) of the excavation to determine the soundness of the metal. Upon completion of the testing this QA Inspector verified that no rejectable indications were present.

This QA Inspector randomly observed ABF welder Salvador Sandoval (Welder ID 2202) performing the repair welding operation of ultrasonic indications as per the Shielded Metal Arc Welding (SMAW) process in the (1G) flat position on “A” deck Lifting Lug Hole 11E/PP103/E3/W2. This QA Inspector observed the use of E7018-H4R electrodes and QC Inspector Sal Merino verify that the preheat temperature was at the minimum of 10 degrees C and that the welding parameters (Amps=135) were in accordance with WPS D1.5-1001- Repair. The welding parameters observed at this location appeared to be in general compliance with approved WPS and the contract specifications.
